### Site 328 Rings Island – First Street and March Road

Great Marsh Coastal Wetlands Restoration Plan  
Rapid Technical Assessment Site 328

# Site 328: Rings Island, 1st St./March Road, Salisbury, MA

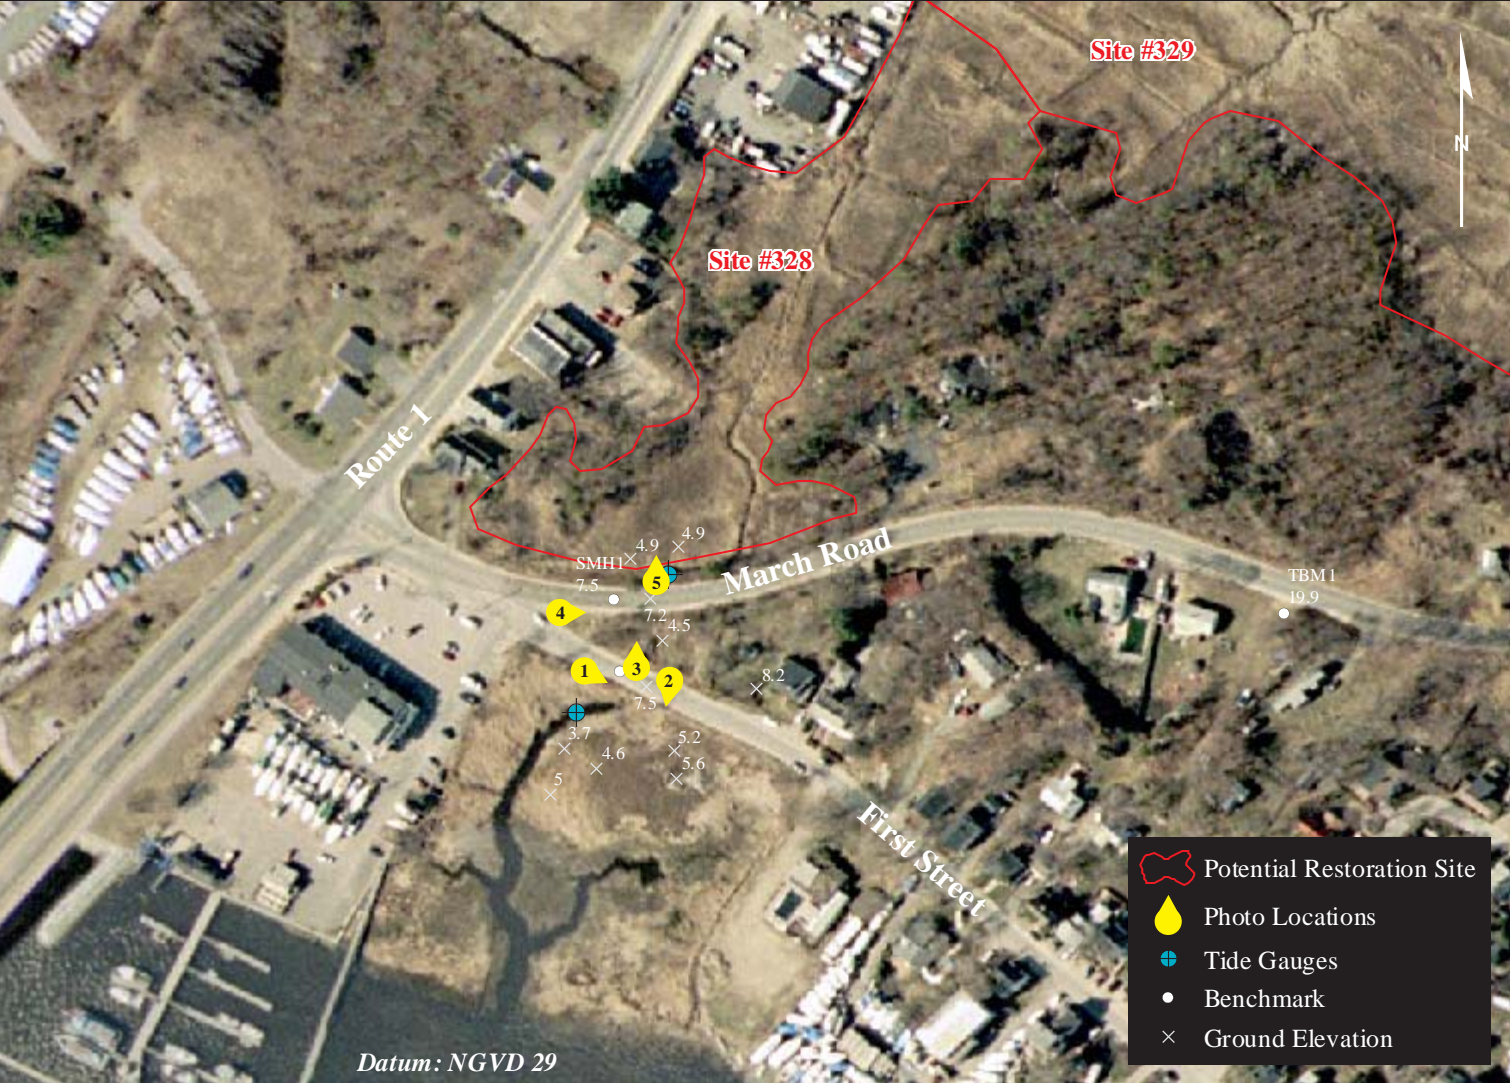
**Structure conditions:** Both ends of the existing culvert under First Street are obscured by riprap and accumulate wrack and debris which prevented visual inspection. The approximate length of the culvert is 40 ft. The culvert appears to be a severely deteriorated timber box culvert of unknown dimensions. The likely original size of the structure is 4 ft by 2 ft (D. Levesque, DPW Director, pers. comm.). Overall, the culvert is considered to be in poor or failed condition. A more thorough inspection would require cleaning and maintenance at the inverts. The life expectancy of the culvert is less than 5 years. First Street is approximately 26 ft wide with a sidewalk on the downstream side of the road and cable guardrail on both sides. The roadway is showing minor signs of collapsing near the culvert but is in fair overall condition with recent major patching of the roadway surface.

The second culvert is an 18 in RCP culvert under March Road. The downstream end of the culvert is located within the triangular-shaped marsh within the median between the two roads. The upstream end of the pipe connects to a linear ditch which parallels March Street for approximately 95 ft before veering to the north. The downstream end of the culvert is protected by a concrete end section while the upstream end has no protection from scour or erosion. The approximate length of the culvert is 53 ft. Overall, the 18 in culvert under March Street is in fair condition with a life expectancy of over 25 years. March Street is approximately 30 ft wide with broad shoulders and cable guardrail on both sides. The roadway is in good condition.

Another, more promising option would involve ditch enhancements to establish a better tidal connection to the larger marsh to the north coupled with the creation of a larger opening under Ferry Street (see Site 329). Construction costs associated with this option are estimated to be \$60,000 which includes creation or enhancement of existing ditch network within the marsh along with maintenance and shorter-term repairs of the culvert under First Street.
